INCREASING LIFETIME BY REPAIRING DEFECTS AND DAMAGE IN BRICK BUILDINGS

Abstract

This article examines brick buildings and the reasons for their flaws and damage. Beacons are used to detect and eradicate faults and damage in building structures. The challenges of boosting the building's durability, reliability, energy efficiency, and human safety by using carbon fiber composite material in the reinforcement, as well as enriching the building's artistic and architectural look, were also studied.

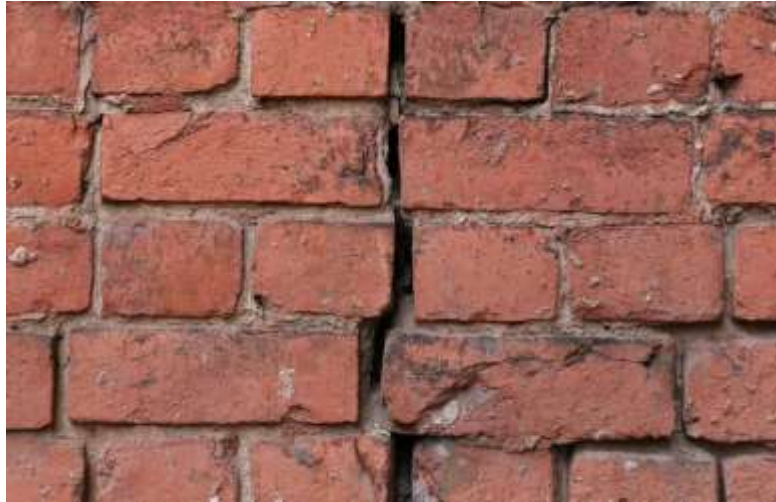
Figure 1. A crack formed at the end of a defect in the brickwork.

The main causes of cracks in brick buildings - uneven subsidence of the ground, ie, subsidence of the middle or outer parts of the ground, incomplete and unreliable engineering-geological studies, violation of technology in the construction of the foundation, errors in determining the load -bearing capacity of the soil during the design process, violation of the normative operating conditions provided for in the project, rising groundwater, failure of the communication system, digging a trench or trench near the building, the degree of loading on the adjacent sections of the walls and the wetting of the subsurface soils and a number of similar reasons can be exemplified in Figures 1 and 2.

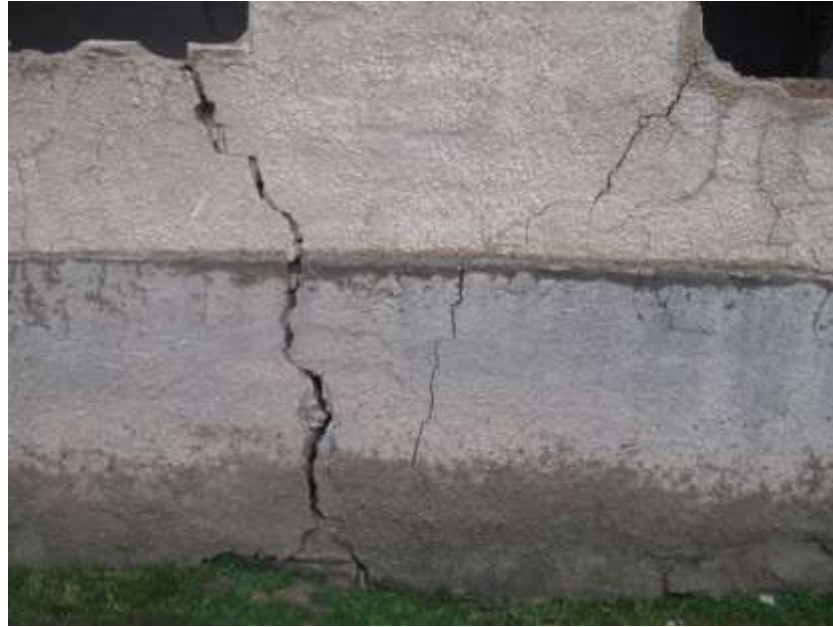
Figure 2. A crack formed as a result of uneven subsidence of the soil of the building. In the case of small and relatively low-risk cracks in the walls of the building, such as landslides in the upper layer of plaster, it is possible to eliminate existing damage by re-plastering and painting.

The team operating under load, i.e. as a result of technological faults during the team's formation and an increase in the load, can cause cracks in load-bearing brick walls. Cracks are an outward evidence of structural pressure and deformation. According to their value, they are categorized into harmful and safe species. When cracks are discovered in a structure, it's critical to understand their cause, details, progression, and stability. The width of fissures formed by the subsidence of foundations and other structures widens upwards, and the ground subsides upwards as a result. Depending on the direction of the cracks that appear, it is possible to determine where the building is sinking [6]. If the cracks are spread in a sloping direction from the edge of the building to the center, from the top down, then a sinking will have formed at this edge of the building. If the cracks are sloping from the top of the building to the edge of the building, then the middle part of the building will be sunken, see Figure 2.

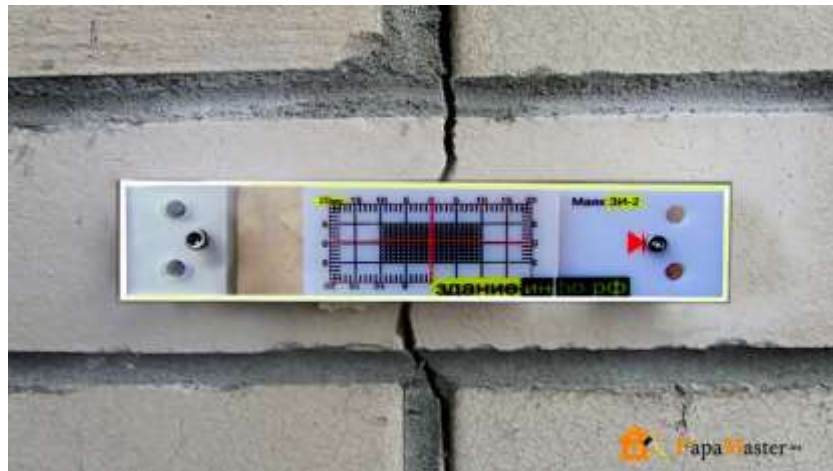
Figure 3. The process of observing cracks using beacons.

The appearance of cracks in brick buildings is a signal indicating the pre-emergency situation. Cracks are usually visible when they reach 0.5mm. Such cracks also transfer moisture and cold to the building. The cracks in the walls of the building are marked on the cracks in order to observe the movement. If the expansion of the cracks occurs quickly, it can take two weeks, and sometimes the process can take several months. If it is determined that the cracks continue to expand, the foundation of the building will be opened and the foundation will be reinforced.

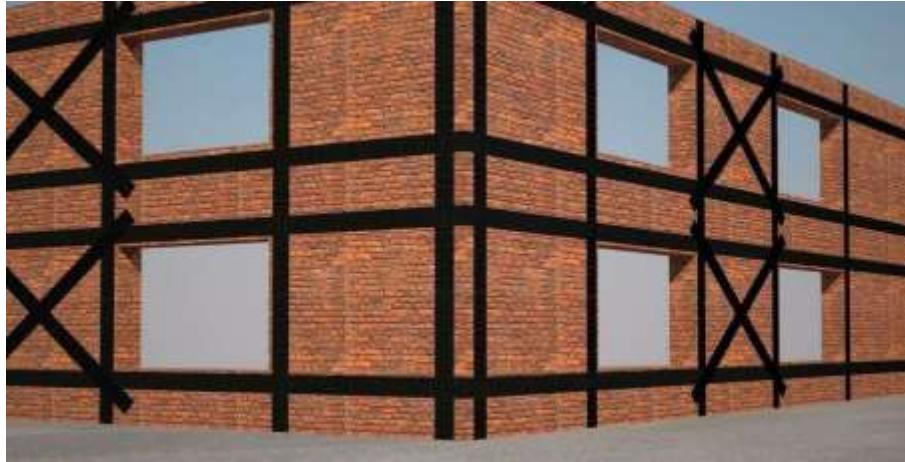
Figure 4. Reinforcement of bricklaying using composite material.

When using composite material to reinforce brick building walls, no holes are bored in the wall and no additional harm is caused to the structure. This procedure entails removing the plaster from the damaged wall surface and applying the composite material in the form of tape to the wall with a particular glue. The composite material begins to interact with the wall as soon as it is joined to the wall, ensuring the building's full strength (see Figure 4).
